HOUSE DAMAGE ASSESSMENT

URS Research Company

June 1972

Summary Report
HOUSE DAMAGE ASSESSMENT

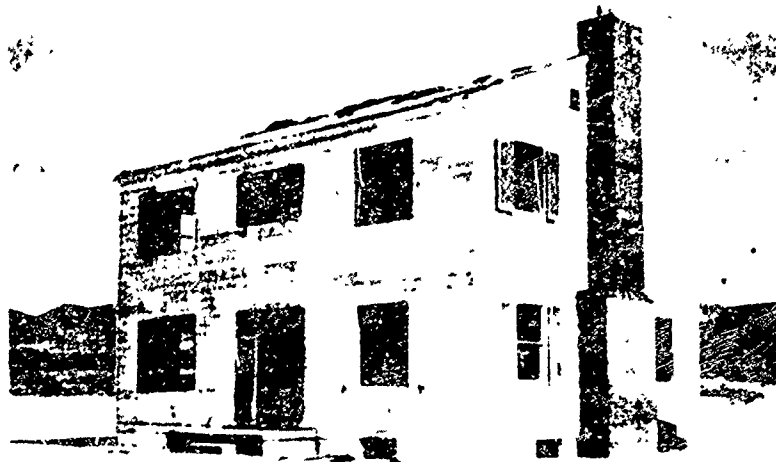
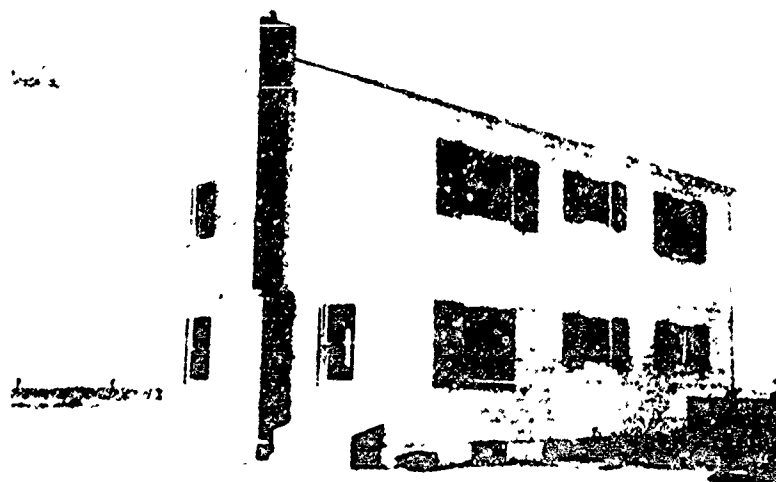
Fig. 2-1. Post-Test Photos, House I-1

This house was located at 7500 ft from ground zero where the incident peak overpressure was 1.7 psi. Post-test photographs of the exterior of the house are presented in Fig. 2-4. Doors, windows, and window frames were either blasted out of the walls or remained in place in a badly damaged condition. In general, the window glass was shattered into small particles and scattered uniformly about the exterior of the house. The only windows

remaining intact were four windows at the rear of the house which were sheltered by interior partitions, and the rear basement windows, which were blown open inwardly. The majority of the 2- by 8-in. floor joists of the front floor system were undamaged. Exceptions were a broken joist under the kitchen, three broken joists under the dining room, and the damage under the living room as shown in Fig. 2-5.

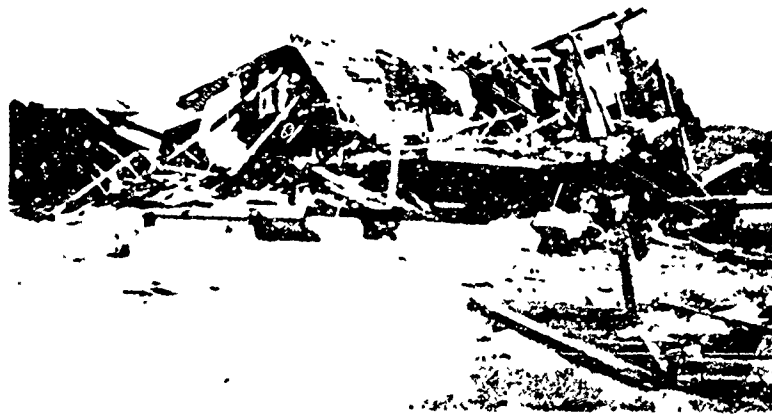
Fig. 2-12. Front of House I-2

This house was located at 3500 ft from ground zero where the incident peak overpressure was 5 psi. Figures 2-12, 2-13, and 2-14 show the front, side, and rear of the house after the blast. The house was demolished beyond repair. Figure 2-15 shows the large area over which debris was scattered. The front half of the roof broke in the middle at approximately the mid-span of the rafters, with the lower part lifting at the eaves, pivoting about the breaks and sailing through the air, then landing on the ground at the rear of the house. See Figs. 2-16 through 2-19 for enlargements of motion picture frames taken of the test.

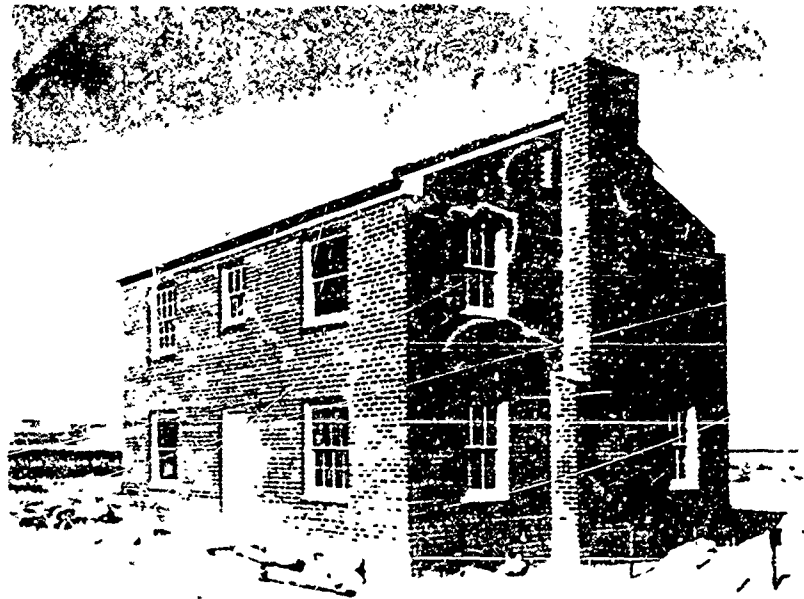
This house was located 10,500 ft from ground zero where the incident peak overpressure was 1.9 psi. There was no apparent damage to the masonry of this house (see Fig. 3-4). However, there was considerable damage to the roof and second floor ceiling framing (see Fig. 3-5). The connections of the rear rafters to the ridge failed, and the rafters dropped 4 to 6 in. below the ridge. The ridge split in the center portion, and some of the 2- by 4-in. collar beams broke in half. The ceiling joists over the rear bedroom split at midspan, and the lath and plaster ceiling was blown down into the room. The second floor framing suffered little or no damage. A few first floor joists were fractured (see Fig. 3-6). The glass in the front and side windows was blown in, and the glass in the rear windows suffered some damage. The exterior doors were blown in and demolished, and several interior bedroom and closet doors were blown off their hinges. The stair rail was broken, and the interior plastered wall and ceiling finish were badly damaged.

Fig. 3-4. Post-Test Photo, House II-1

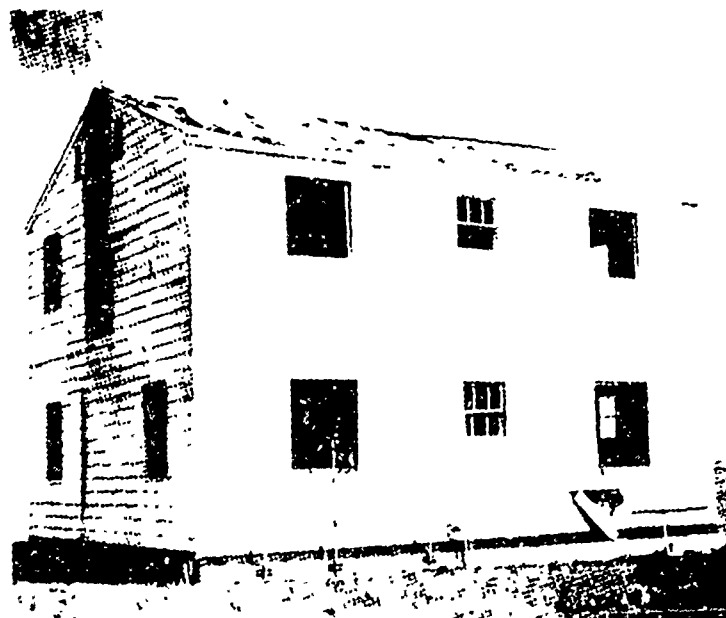
Fig. 6-9. House Damage Summary, House No. I-9

Peak Overpressure (psi) 2.7
Charge Size (ton) 500

Positive Phase Impulse (psi-msec) ~ 340
Ground Range (ft) 2256

ITEM	DAMAGE PERCENT (each element)	CHANGE PERCENT (total value)
Floor and Ceiling Framing	0	0
Roof Framing and Roof Surface	60	4.2
Exterior and Interior Wall Framing	23	3.7
Interior Plaster	40	4.4
Exterior Sheathing and Siding	20	1.7
Doors	67	3.1
Windows	93	4.5
Foundation and Basement	0	0
Misc.: Stairs, Fireplace, Paint, Trim	30	3.6
TOTAL		25.2

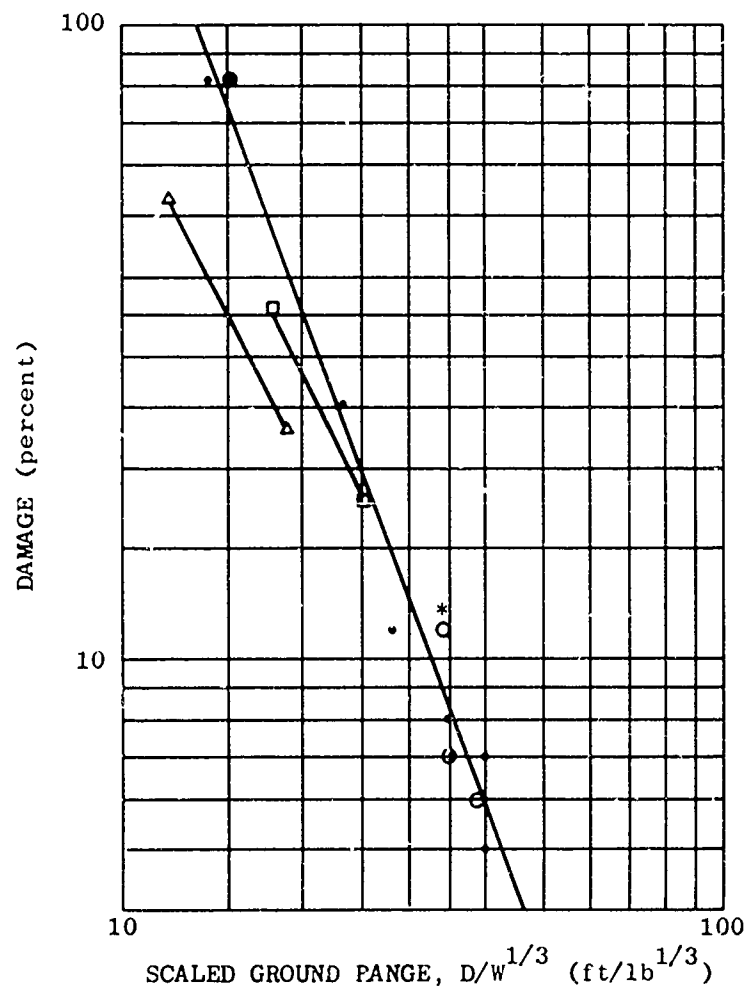
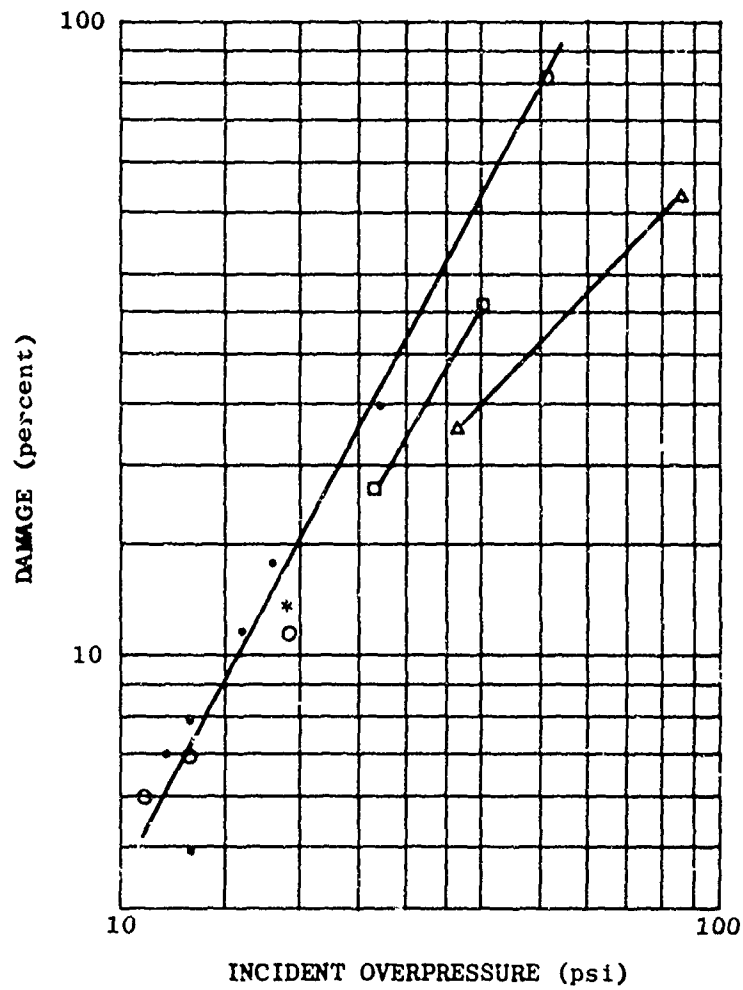
On the other hand, damage appears to correlate reasonably well with either overpressure or scaled ground range ($D/W^{1/3}$). This is borne out by Figs. 6-20 and 6-21. In both figures there appears to be little difference in response for Types I, II or III houses. That is, one and two story ordinary (unstrengthened) wood frame houses and two story masonry houses (without shear walls) appeared to behave essentially the same. Strengthened wood frame houses and houses with heavy shear walls received significantly less damage.

Fig. 6-20. Percent Damage vs Scaled Ground Range

Fig. 6-21. Percent Damage vs Incident Overpressure (psi)

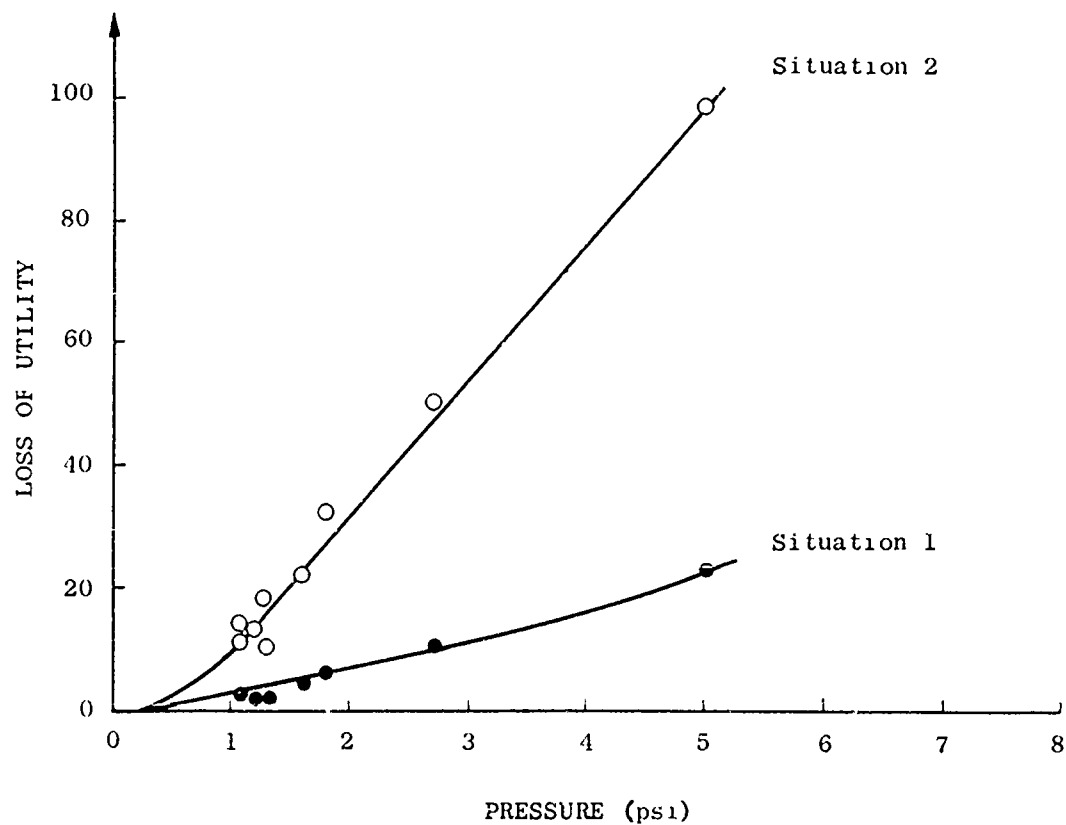
Fig. 7-1. Loss of Utility vs Overpressure for Subjective Analysis

It is clear from the foregoing exercise that the subjective value analysis is not at odds with the objective analysis at all. The "subjective" analysis adds further dimension to the objective analysis and allows the decision maker to adjust for use of the damaged structure other than originally intended if required. It is interesting to observe that the subjective analysis is just as well behaved as the objective analysis when plotted against the overpressure, which is intuitively pleasing. This presentation is far from complete, but it does seem to warrant some further investigation.

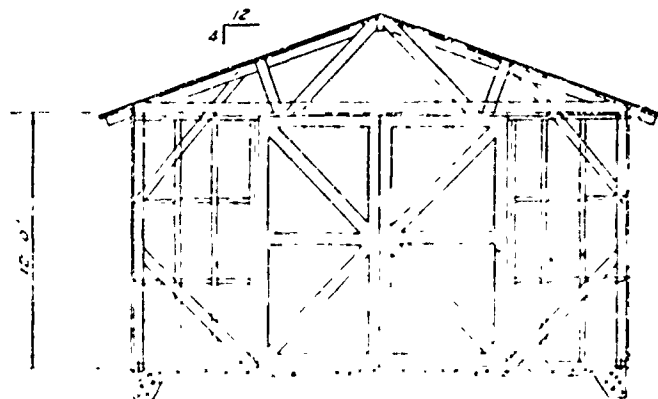
Warehouses, Structural Damage

The construction details are shown below. The framing consisted of 2- x 4-in. studs, and 2- x 4-in. trussed rafters with a 2- x 6-in. bottom chord 2 ft o.c. and with a 2- x 4-in. knee bracing 8 ft o.c. The siding was 3/8-in. exterior plywood and the roofing was of corrugated aluminum sheet metal secured to 1- x 4-in. nailing strips. The size of the building was estimated to be 25 x 60 ft.

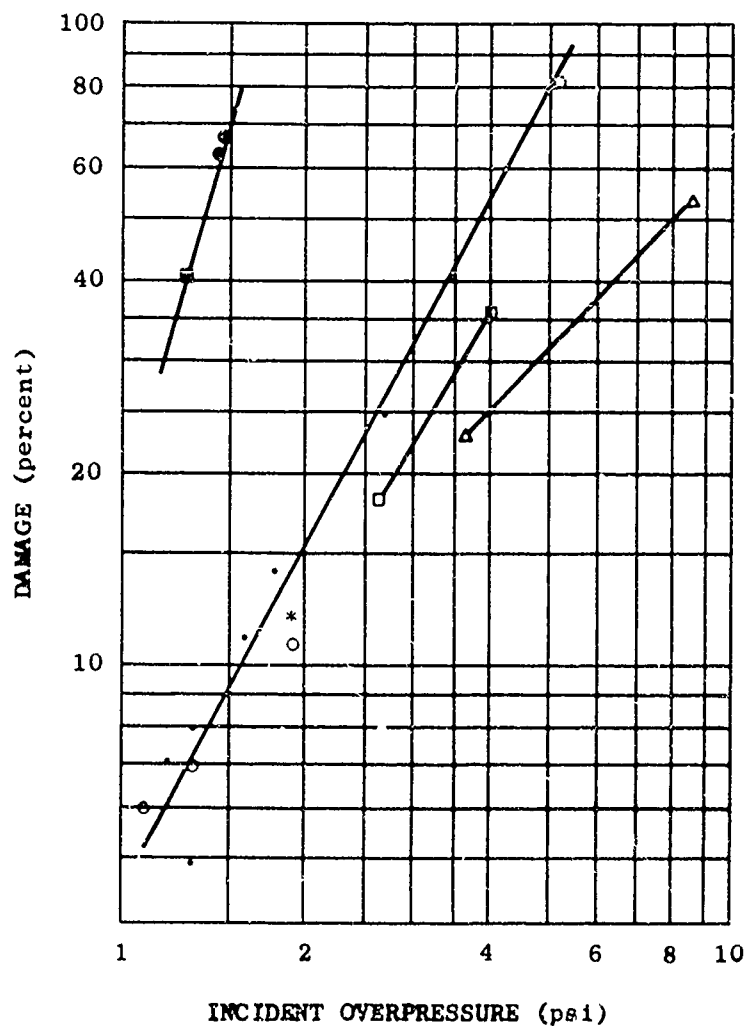
Fig. B-1. Percent Damage vs Incident Overpressure (psi)

noted that these structures are considerably weaker than the Type I house, that is, they sustained more damage at the same overpressure.
